SUBJ: RCRA Compliance Evaluation Inspection
Chemical Waste Management
EPA ID# ALD000622464

RCRA Inspection Report

ADEM Hazardous Waste Permit Number ALD000622464

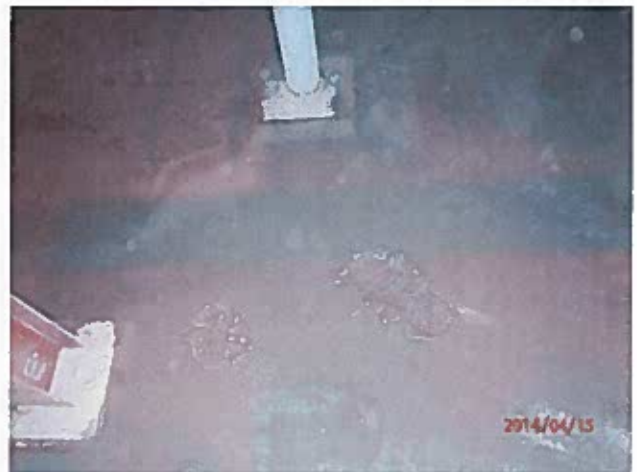
Outside the building the inspectors observed two dust control silos (Pictures 34-37). Inside the Silo#2 Baghouse building was two roll-offs filled with hazardous waste dust (Pictures 38-43). The inspectors observed dust and water on the ground around the roll-off. The inspectors stated the dust and water represented a housekeeping issue. Mr. Sturdivant explained that a work order was issued for the cleanup.

Picture 40 – Stabilization Dust Control Silo#2 dust mud

CWM Emelle is in apparent violation of Hazardous Waste Permit Condition I.C.4. In the event of noncompliance with this permit, the Permittee shall take all reasonable steps to minimize releases to the environment, and shall carry out such measures as are reasonable to prevent significant adverse impacts on human health or the environment.

CWM Emelle is in apparent violation of Hazardous Waste Permit Condition V.E. Throughout the active life of the containment building, if the Permittee detects a condition that could lead to or has caused a release of hazardous waste, the Permittee must repair the condition promptly, in accordance with the following procedures and the requirements of ADEM Admin. Code R. 335-14-5-.30(2)(c)3.

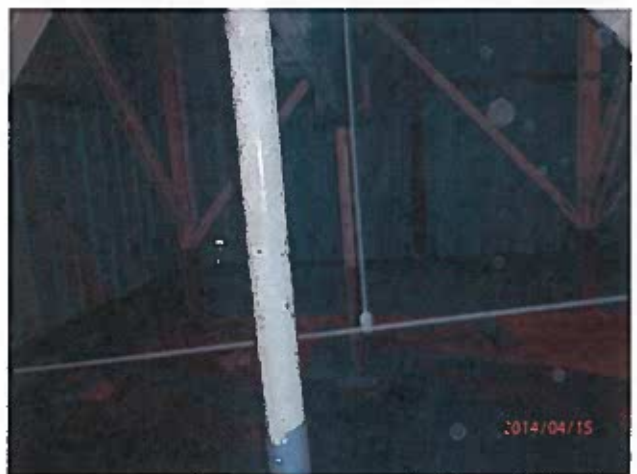
Picture 41 – Stabilization Dust Control Silo#2 building with holes in the side

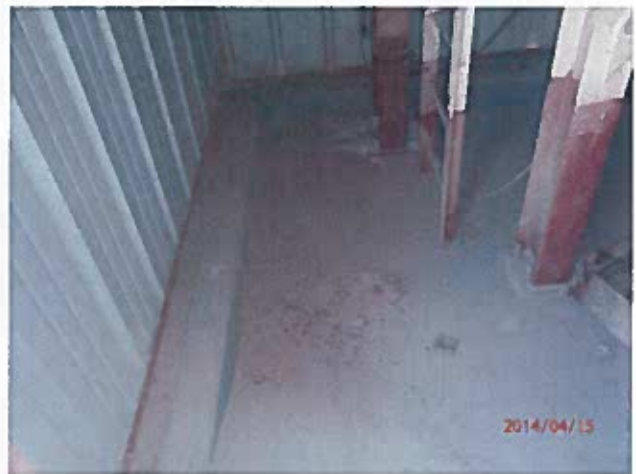
In Silo#1 Baghouse building, the inspectors observed a covered roll-off with hazardous waste dust, the floor and the steel beam footings were covered in dust, about half the floor space had standing water and the corrugated metal walls were rusted along the bottom with holes (Pictures 44-59). The inspectors requested the inspection logs to determine when the housekeeping issues noted were last documented. A work order RWO#04911 was opened on April 15, 2014 for the removal of the water and dust. The work order was closed on April 16, 2014.

Picture 59 – Stabilization Dust Control Silo#1 steel beam footings covered in dust

CWM Emelle is in apparent violation of Hazardous Waste Permit Condition I.C.4. In the event of noncompliance with this permit, the Permittee shall take all reasonable steps to minimize releases to the environment, and shall carry out such measures as are reasonable to prevent significant adverse impacts on human health or the environment.

CWM Emelle is in apparent violation of Hazardous Waste Permit Condition V.E. Throughout the active life of the containment building, if the Permittee detects a condition that could lead to or has caused a release of hazardous waste, the Permittee must repair the condition promptly, in accordance with the following procedures and the requirements of ADEM Admin. Code R. 335-14-5-.30(2)(c)3.

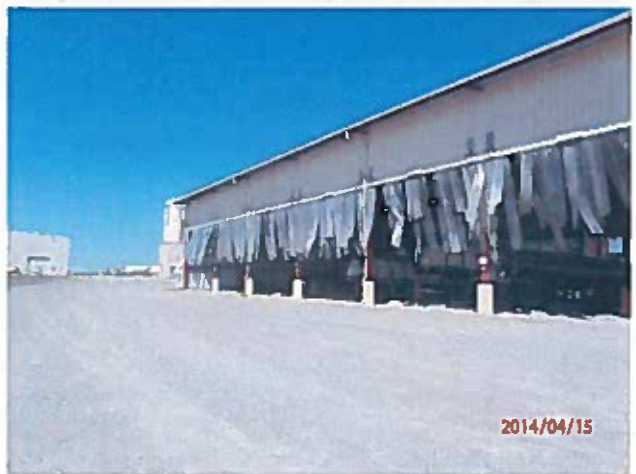
Picture 60 – Building 2200 Container Storage

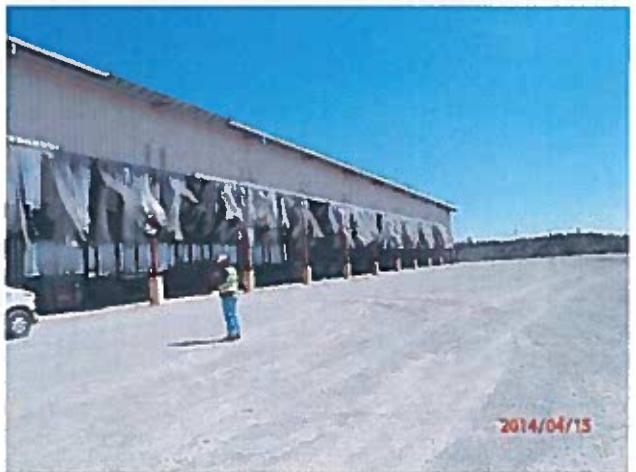
Picture 61 – Building 2200 Container Storage

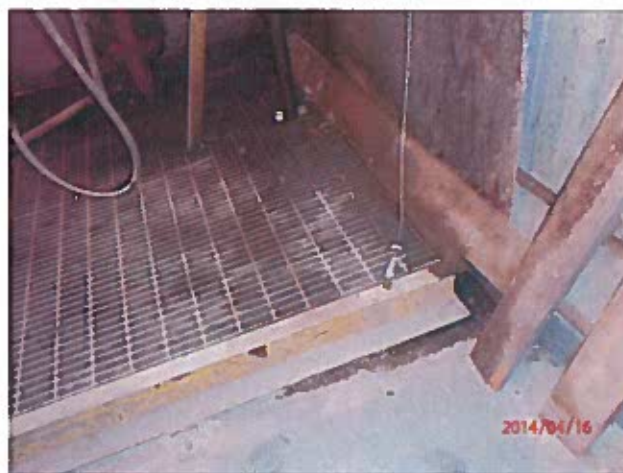
The inspectors observed a PCB only parts washer, eight PCB capacitors, a flatbed with incoming drums and Gaylord boxes and a concrete PCB/RCRA organic waste intake berm that goes to the hazardous waste tanker located between Buildings 604 and 600. At the time of the inspection, the inspectors observed a stain on the floor outside of the berm (Pictures 127-129). The facility was unaware of the stain on the floor.

Picture 129 – Building 600 TSCA Storage organic waste pit floor stain

CWM Emelle is in apparent violation of Hazardous Waste Permit Condition I.C.4. In the event of noncompliance with this permit, the Permittee shall take all reasonable steps to minimize releases to the environment, and shall carry out such measures as are reasonable to prevent significant adverse impacts on human health or the environment.

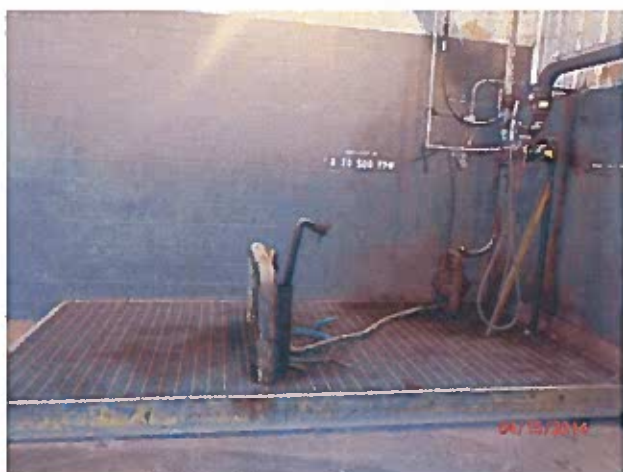
Picture 127 – Building 600 TSCA Storage organic waste pit

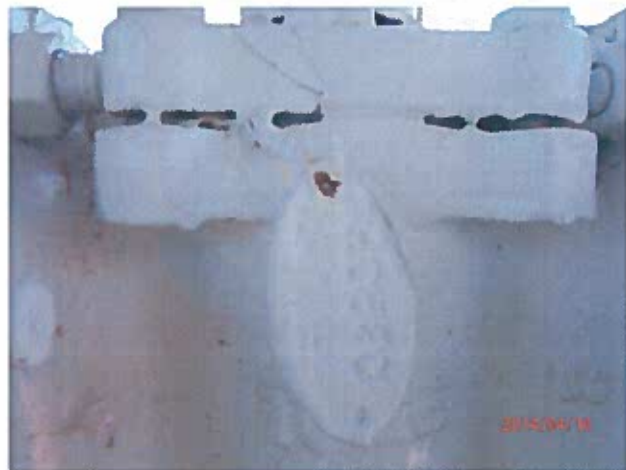
The Hazardous Waste Tank (Pictures 142-153) pumps into Tanker 08, which at the time of the inspection, was empty. The inspectors observed that the permitted hazardous waste tank had Subpart BB tags at the flanges and connections. Some of the tags were missing, and some were difficult to find and read because the tags were painted over. The inspectors recommend removing the paint from the painted over BB tags to make them more easily accessible. Mr. Rickey Burrell later provided a work order (RWO #04987) dated March 21, 2014 for five new BB tags.

Picture 149 – Building 520 Hazardous Waste Tank BB tags

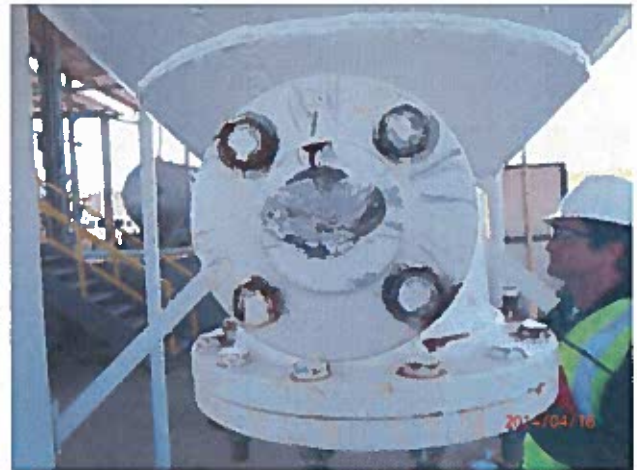
Picture 150 – Building 520 Hazardous Waste Tank BB tags

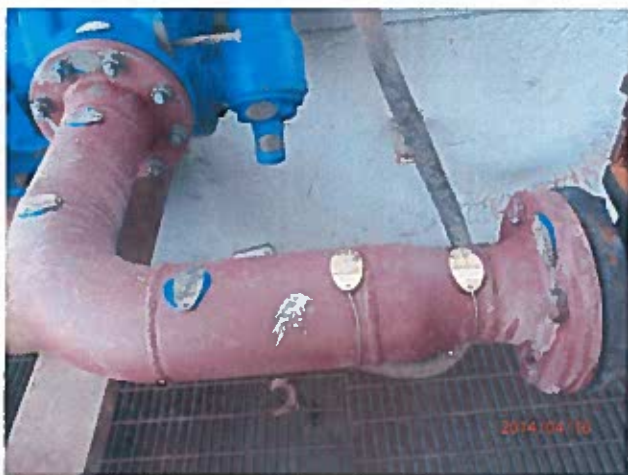
Picture 153– Building 520 Hazardous Waste Tank BB tags
